Manhole Inspection Summary

Manhole # S17QQ1043MH

Insp Date: **6/27/07 11:46 AM**

Location Address: **4890 STRAWFLOWER LN**

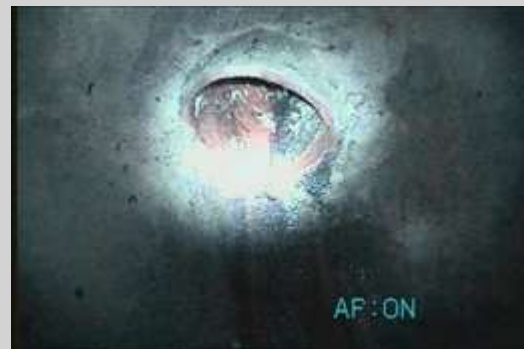
Drop In @ 6 O'Clock

Drop: **Outside** Rod and Bar

Angled: **Yes** Reading: **13.98** (ft.)

Inv Depth: **14.98** (ft.)

Drop Condition: **Open**

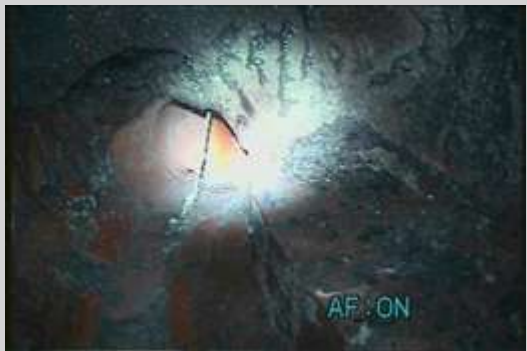
8 in. Circular Gravity Sewer
Pipe In @ 9 O'Clock

Rod and Bar (Angled)

Pipe Material: **Clay** ☐ Pipe Lined

Infiltration: **None** Pipe Seal Cond: **Unknown**
